# Improved Diagnosis of Problems With Critical VFD Motor/Machine Systems

**ABSTRACT:** Despite the growing number and importance of VFD motor/machine systems in industrial applications, predictive maintenance professionals aren't often aware of what is necessary to identify faults to avert catastrophic motor failures. The complexity of the symptoms exceeds commonly used root mean square (RMS) handheld instrumentation, many of which can't even discern symptoms, never mind root causes. This paper presents a pair of VFD applications, problems associated with those applications, and diagnoses from the use of modern field instrumentation.

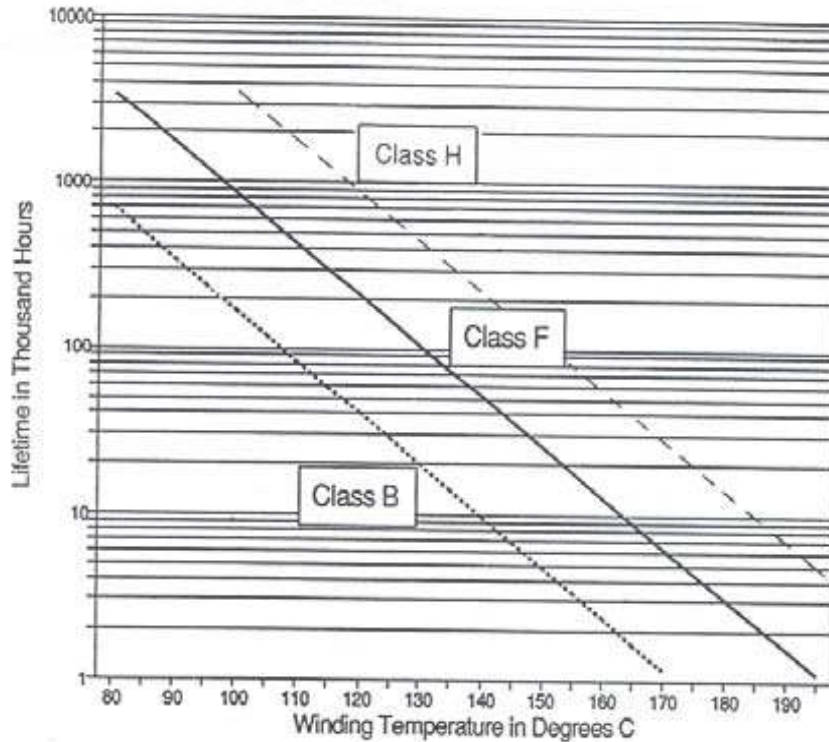
Fig 1: Winding Temperature vs. Lifetime for Insulation Class B, F, & H

The established rule of thumb regarding motor insulation life is that for every 10 degrees Celsius above a motor's rated operational temperature, the life of the motor's winding insulation drops by half (Figure 1).

To apply this concept, a motor operating at 30 degrees C above its insulation's rated temperature reduces the motor's normal life expectancy of 20 years to just 2.5 years. In the case of this company's VFD motor, it drove a log-transport conveyor belt in an operation involving three steps. First, when a log is not in close proximity to the saw, the motor operates at a relatively fast pace. When a log nears the saw, the motor decelerates to a preset cutting speed. Finally, once a log exits the saw, the motor accelerates again to the faster setting. In this particular case, the system is designed so that each log reaches the saw every 15 seconds. The company depends upon the VFD's ability to dynamically change the speed of the belt for efficient operation of this band saw.

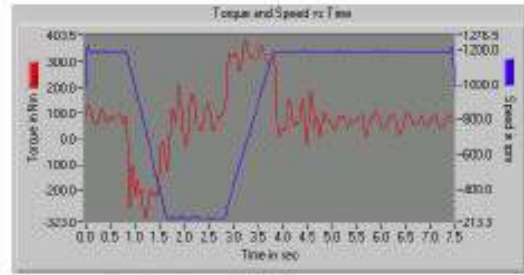
Fig. 2: Speed and Torque vs. time.

Figure 2 reveals a partial cycle (in blue) of the motor’s speed for 7.5 seconds. At the beginning of the cycle the motor is running at 1200 rpm. After one second, deceleration occurs, taking just 0.7 seconds to reach cutting speed, where it remains constant for two seconds. At 2.7 seconds, the drive accelerates and returns to 1200 rpm in just one second, where it remains for the rest of the cycle.

Figure 2 and Figure 3 are screen captures from the display of a dynamic motor analyzer [16]. The red trace in Figure 2 displays torque versus time. Average torque during the first second of operation is 100Nm, which is approximately a third of the rated torque for the motor. The torque for the low-speed operation reveals a similar average, which is common for conveyor belt applications. Both torques during deceleration appear to be roughly constant. These data points adequately correspond with the programmed rate of conveyor deceleration (and negative, which shows that the motor operates as a generator when actively braking). Finally, the monitor shows acceleration exerts a higher torque than the constant speed torque, which is necessary to accelerate the conveyor bearing the

weight of each log. In this case, overall deceleration took 0.7 seconds; acceleration, one second.

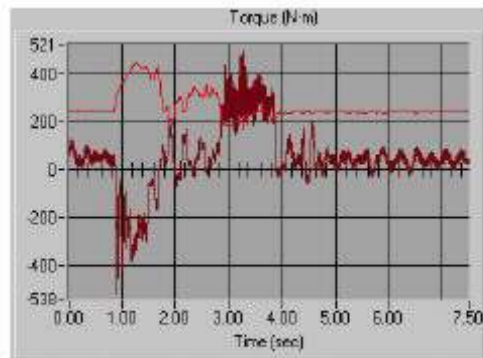
Fig. 3: Torque and equivalent rated torque vs. time.

Figure 3 shows instantaneous torque versus time, and the red line within captures the equivalent rated torque. The motor analyzer calculated this with a motor model that incorporates voltage level, frequency, torque and nameplate information as input variables. The goal of the model was to find thermal equivalent stress relative to rated operation, and for multiple operating frequencies and voltages. The model implemented displayed the torque so that the motor rotor's  $I^2R$  losses are identical to those for full-load operation. This estimation neglects the reduced cooling achieved by shaft-mounted fans when they are operated at lower RPM. Observe that between seconds three and four, instantaneous torque is significantly higher (300Nm) than the equivalent rated torque (200Nm). This calculates to approximately 150% of full thermal loading, and happens every 15 seconds. This is what is causing the motor to overheat.

As a bonus, the monitor revealed second potential fault during the investigation. The VFD-motor-load system was consistently oscillating (or "hunting"). Figure 3 clearly reveals the oscillation in the last 1.5 seconds of instantaneous torque, where about five cycles of the oscillation occurs. After identification of the

frequency, maintenance personnel noticed the repetitive load variation could be heard at the motor during periods of continuous operation. This oscillation did not noticeably degrade the electrical system, but the mechanical system (from conveyor belt to motor bolts) was under unnecessary stress. With help from the vendor's field support the VFD's PID parameters were tuned and provided a much smoother operation, which reduced the audible vibration sound and maintained a comfortable class F temperature range to the VFD-motor-load system.

With the knowledge that this was the problem, the solution involved reducing the requisite torque during conveyor acceleration by a third. The one-second acceleration time was slowed to 1.5 seconds. This slowed production by 0.5 seconds for every 12 seconds or 2 minutes per hour, which was acceptable to operations. The VFD could now handle the new high-speed setting (changed from 60Hz to 66Hz) with no thermal impact on the motor, and still complied with NEMA Part 31 guidelines for VFD operation of standard motors [15]. These changes actually increased productivity by half an hour per shift, while averting premature failure of the motor and any consequential downtime.

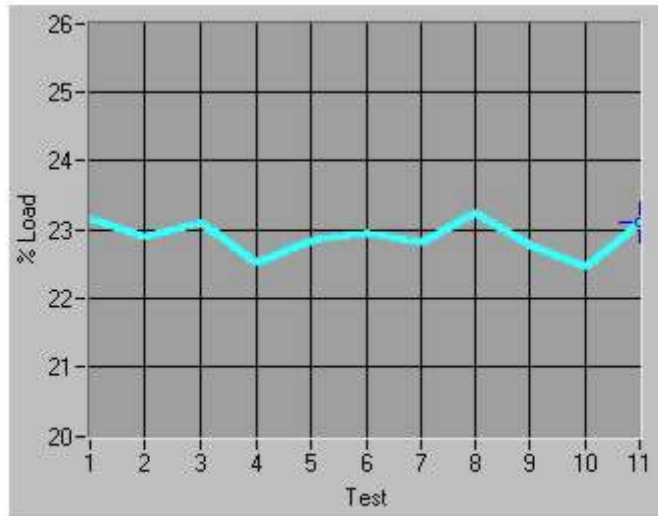
Figure 4: Estimated % load vs. number of test.

These critical 1-hp motors are monitored 24/7, and warranted the installation of the means to log A-phase state current levels. One of the stirrers, however, experienced an increase in the motor stator's current over the last two days prior to the check. In order to avoid unplanned downtime and costly loss of production, the root cause of the problem needed to be found as quickly as possible. Both stirrers were analyzed with a dynamic motor analyzer. Initial considerations made the likely source of the problem related to the load of stirrer No. 2. Figure 4 displays the load condition of stirrer No. 2, and reveals a constant load level between 22.5 percent and 23.2 percent load for 11 subsequent tests. Stirrer No. 1 was also checked, yielding similar results.

This low load is advantageous to the operation because the VFDs were installed 20 feet above the open batch of molten glass. Ambient temperature exceeds 60 degrees C, which required running both motors and the VFD under low load to avoid overheating.

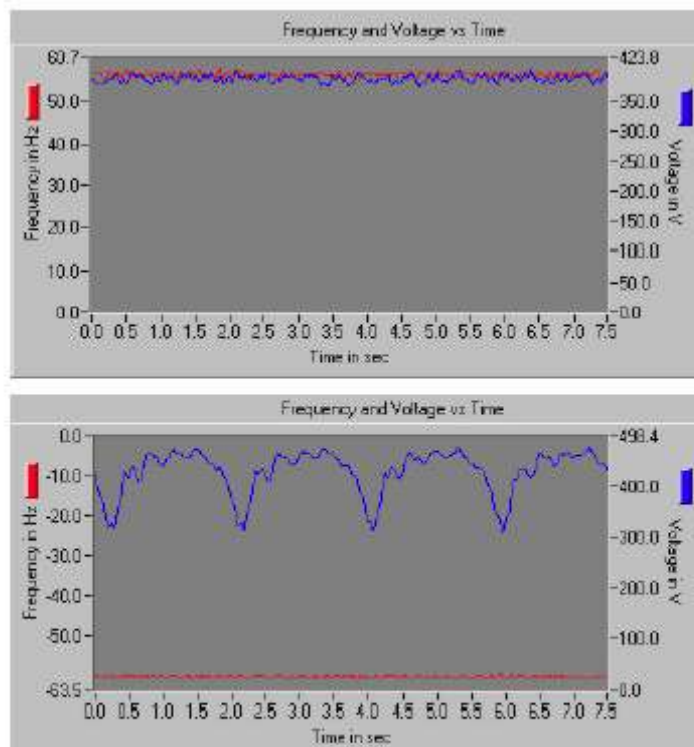
Fig. 5 a-b: Frequency and Voltage vs. time. Stirrer 1 top figure, stirrer 2 bottom figure.

Figure 5 compares other operational values for both VFDs. Figure 5a displays an expected constant frequency of 56Hz for stirrer No. 1 along with a constant voltage level. Figure 5b shows stirrer No. 2 data. A negative frequency of roughly 56Hz is recorded. This negative sequence indicates that stirrer No. 2 was operating in the opposite direction of stirrer No. 1, which is needed to meet the best stirring practice of the molten glass. However, the voltage level varied between 470V and 300V. Since the load does not change, these abrupt voltage collapses cause the stators current to rise. The single-horsepower VFD's control board was not properly regulating the output voltage, and thus the root cause of this symptom was determined to be a faulty VFD. The scheduling of maintenance allowed for an exchange of the VFD when the batch was empty. The flow of production was not impacted, and the cost of repair was minimal.

The high temperature environment the VFD operated under may have precipitated the failing control board. If a pattern of failure emerges for this critical application, then it might necessitate relocating the VFD's further from the molten glass.
